BARRON COUNTY, WI FARMLAND VALUE

WHAT WE THOUGHT WE KNEW

Tile Project Results

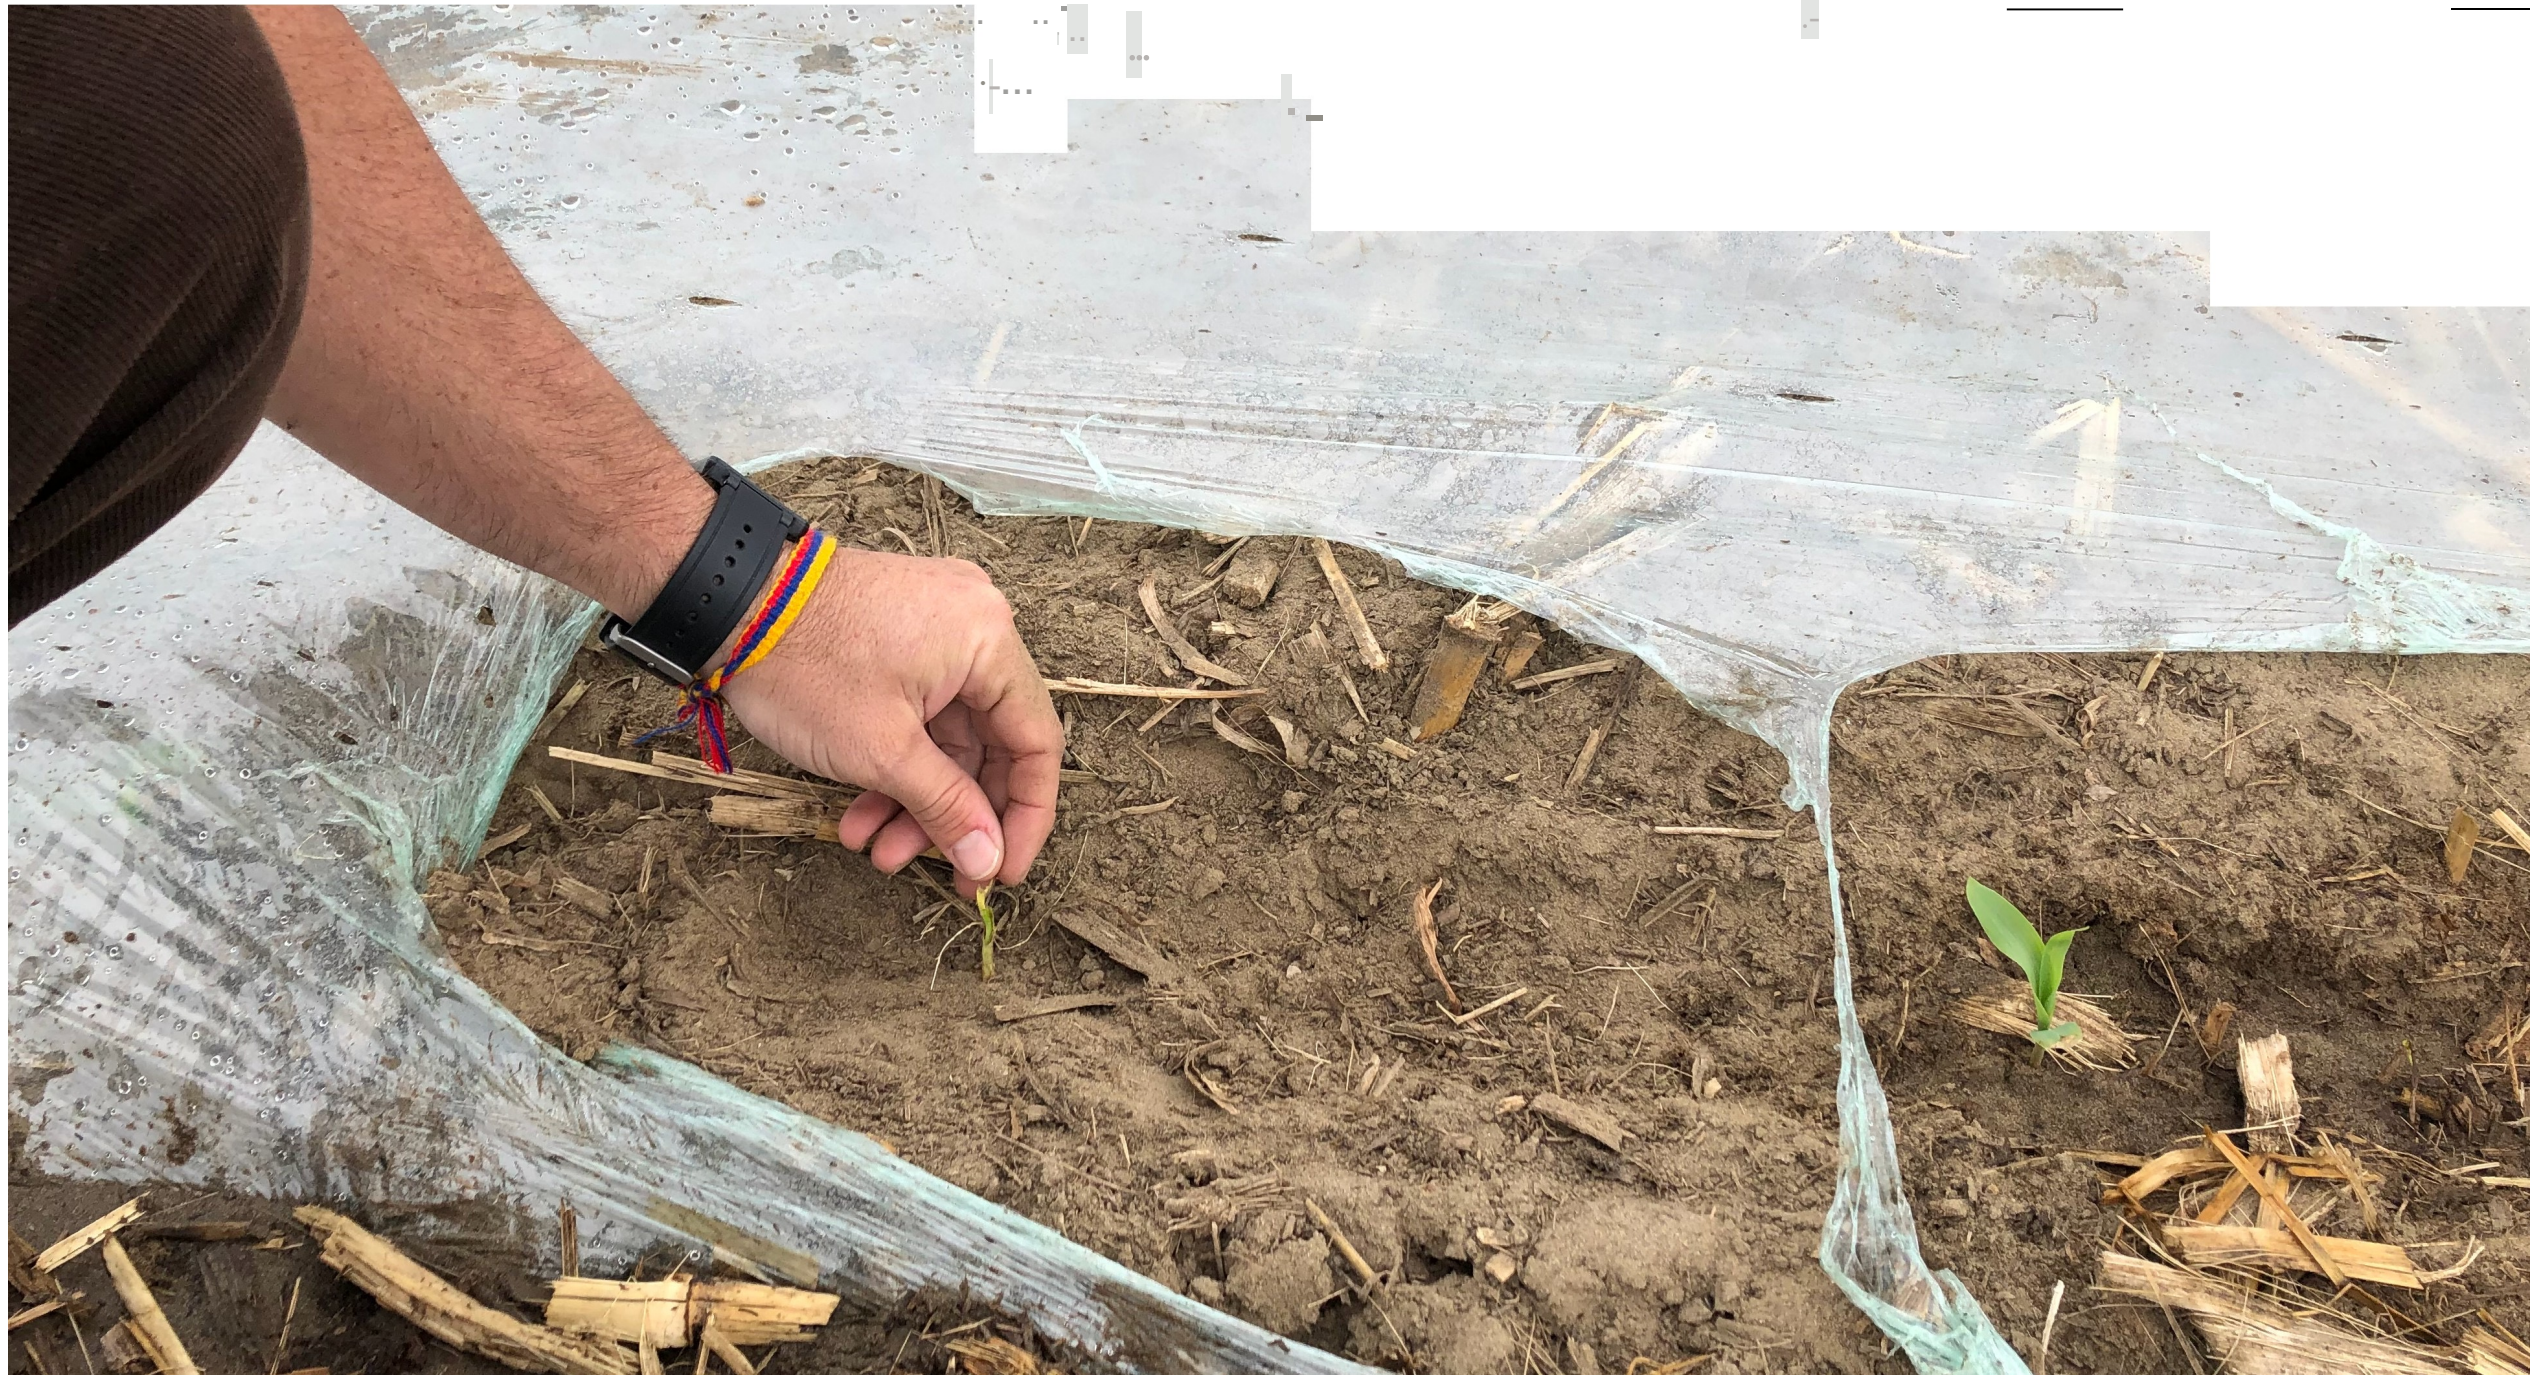
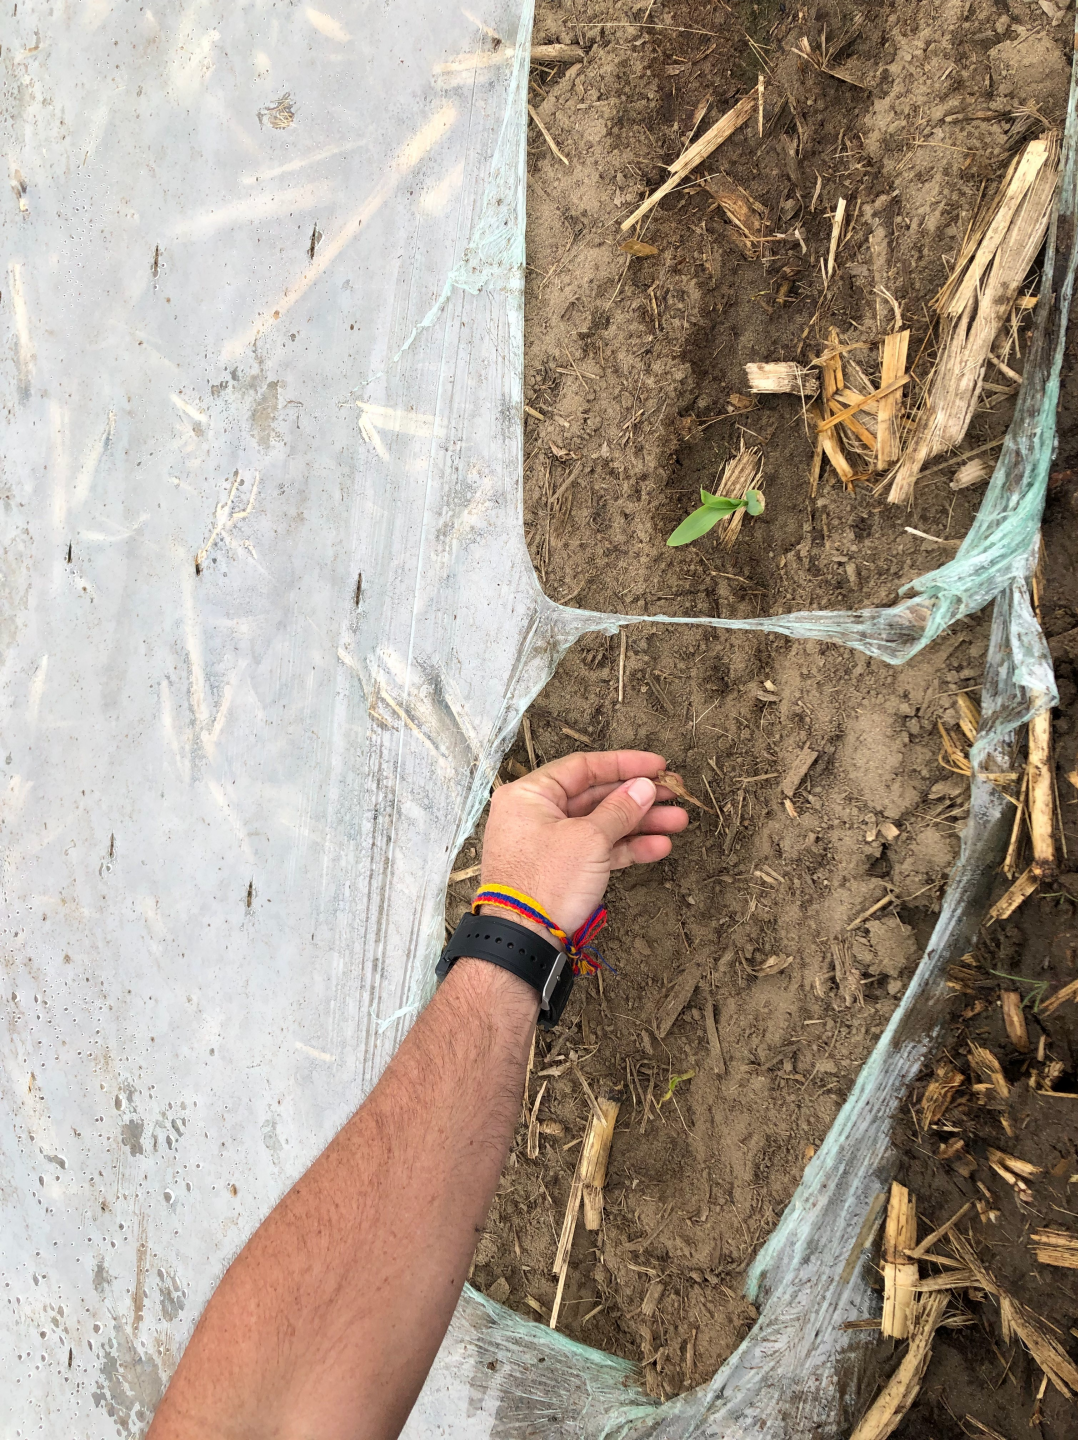
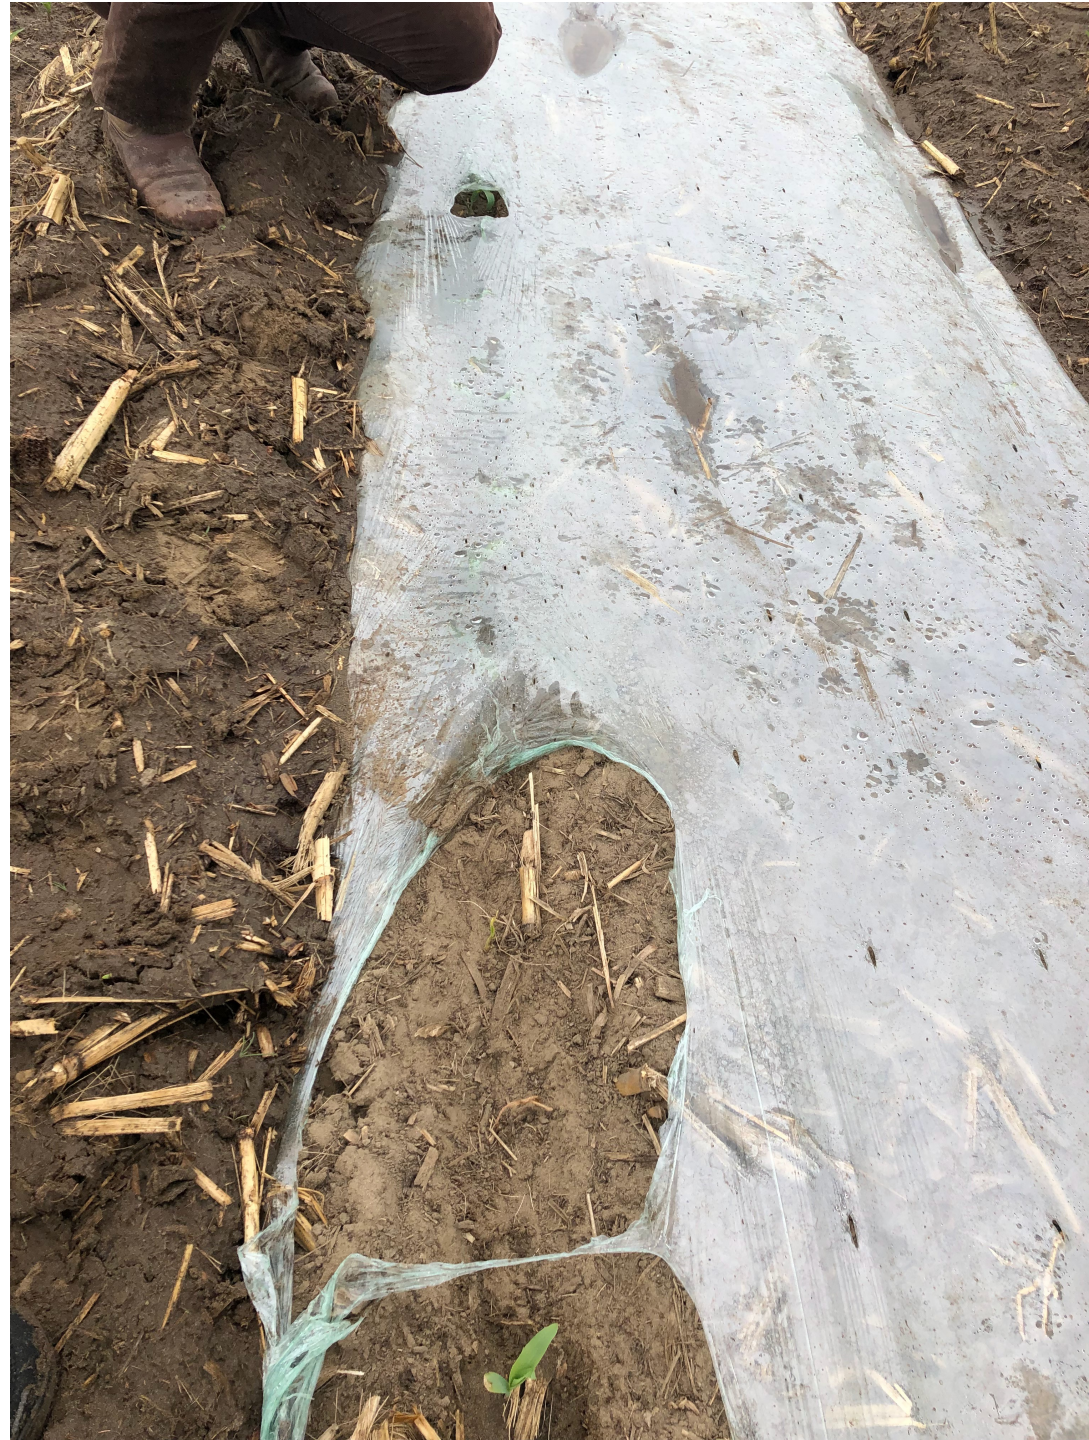
OOPS

In Michelson upon our midnight arrival we saw what looked like a bad stand. In the daylight we realized that while the corn mostly looked great, there were areas that were not germinating because they were bone dry.

Those areas were patchy and depended heavily on the inflow patterns of the irrigation water into the film.

The dry soil was very close to saturated soil, but there was little horizontal movement, and it stayed dry through multiple irrigation passes.

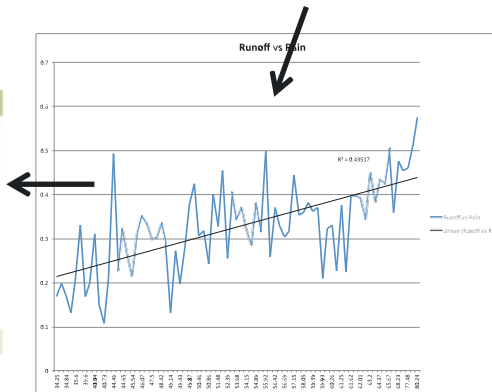
Scenarios of Water Availability

Correlation between Runoff (River Flow) and Rainfall

Dry Year		West Parcel	East Parcel
Annual Rainfall	<i>inch/yr</i>	35.0	35.0
Runoff	%	18%	18%
Area	<i>ac</i>	7,276	8,347
Flow	<i>ac.in</i>	45,839	52,586
Flow	<i>ac.ft</i>	3,820	4,382
Area to Irrigate	<i>ac</i>	3,072	1,604
Water needed	<i>in/ac</i>	14	14
Water needed	<i>ac.in</i>	43,008	22,456
Water available	%	107%	234%

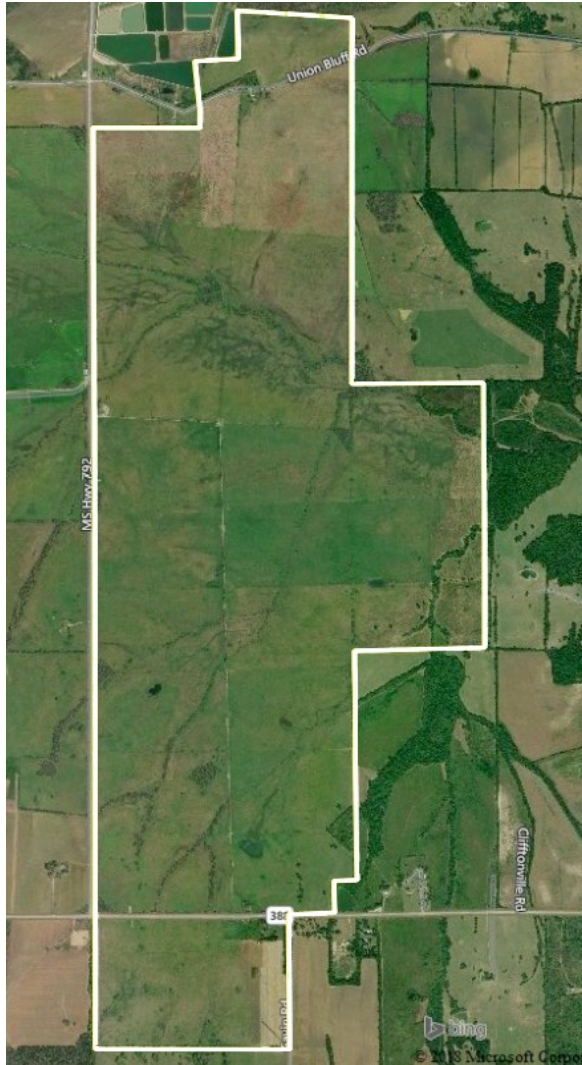
TILE

282 ac
30 ft spacing
282,900 ft laterals (3", 4")
12,000 ft laterals (6", 8", 10", 12", 15")
350 connections (bedding material
used for each of those connections)

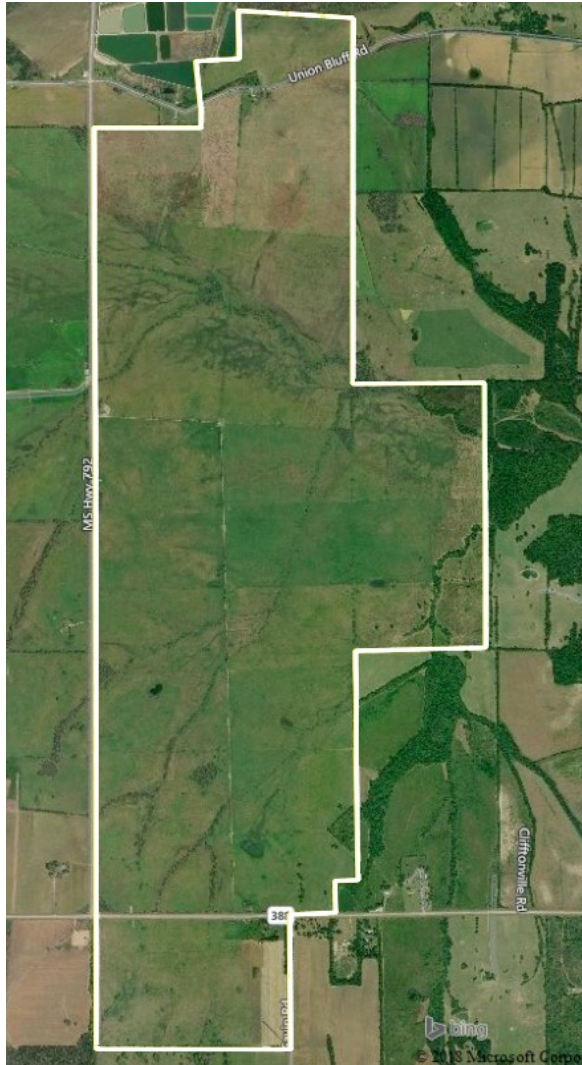
DEERBROOK

TILE NORMALLY INSTALLED IN
CATALPA, GRIFFITH AND LEEPER
SOILS SERIES

Catalpa: 305 ac
Griffith: 485 ac
Leeper: 293 ac
Total: 1083

TILE INSTALLED 2018
282 ac

REMAINING TILE
500 ac (estimate)
